# Building Inspection Report

**123 Any Street, Our City**

**Inspection Date:** July 2, 2007

**Report Number:** 1234

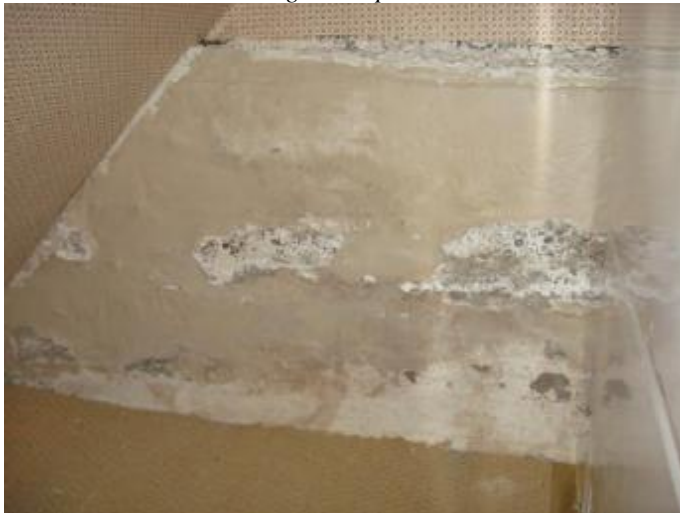
- **Repair:** We observed substantial efflorescence and spalling on the foundation walls in the basement at the left rear indicating an excessive moisture condition (see Basement below). *Efflorescence is a white powdery deposit which occurs on masonry or concrete. Efflorescence indicates the presence of moisture in contact with the masonry or concrete. Substantial efflorescence usually indicates a defective drainage condition. We recommend the drainage be improved.*

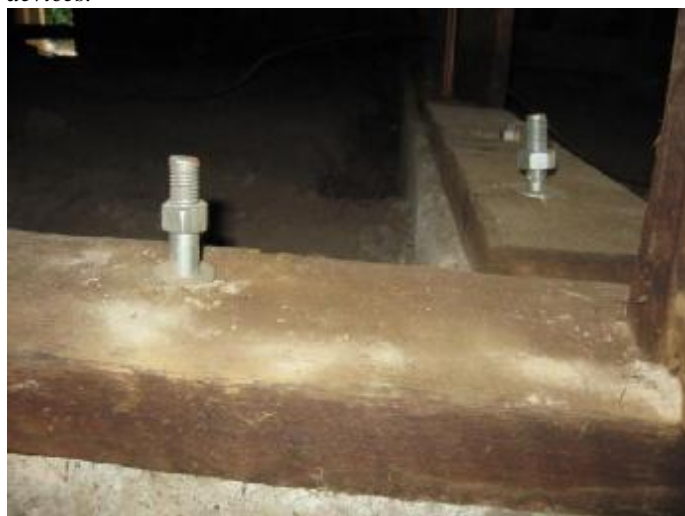
- **Repair:** Anchor bolts have been added to the foundation in several places. Several of the bolts are not fully driven into the foundation at the right front. We recommend additional bolts be installed by a qualified contractor where needed.

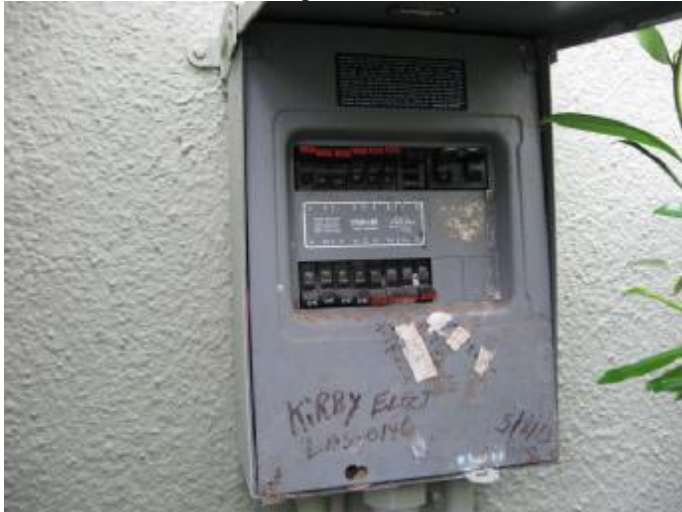
- **Major Concern:** This panel is an outdated Federal Pacific Stab-Lok type. There has been some recent concern that panels of this type and other discontinued brands may not operate safely in some conditions. The installation of a new panel may be the only way to eliminate potential risks associated with outdated panels. Additional information on this type panel can be found at <http://www.inspect-ny.com/fpe/fpepanel.htm>. We recommend this panel be replaced with a modern circuit breaker panel.

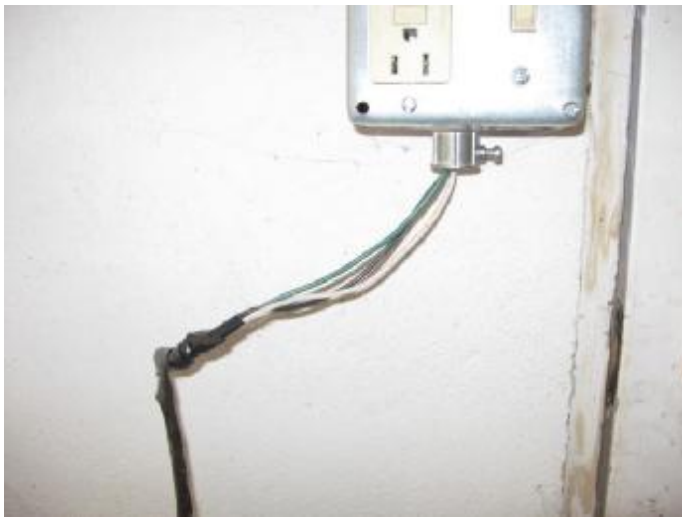
- **Repair:** There is a dangling loose end wire in the garage. We recommend this wire be properly installed by a qualified electrician.

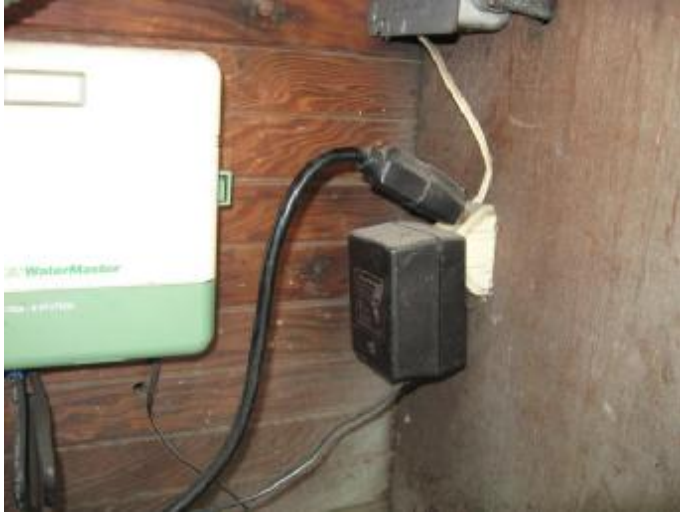
- **Repair:** The exterior outlet at the right front exterior compartment is not GFCI-protected as required in new construction (see GFCI's above). We recommend GFCI protection be provided.

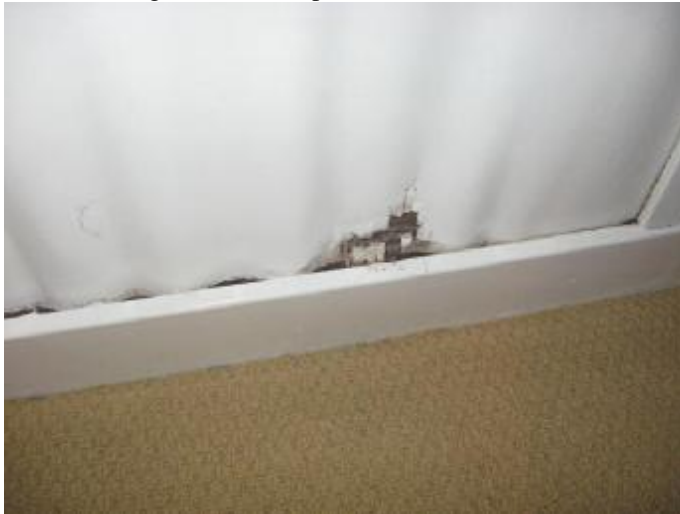
- **Monitor:** There are several cracks in the interior surfaces. Surface cracking is common and periodic repair should be expected as part of routine maintenance.
- **Repair:** The bottom edges of the walls in the basement room at the right rear are damaged by moisture. We recommend the damaged wood be replaced. We recommend examination by a qualified pest control firm.

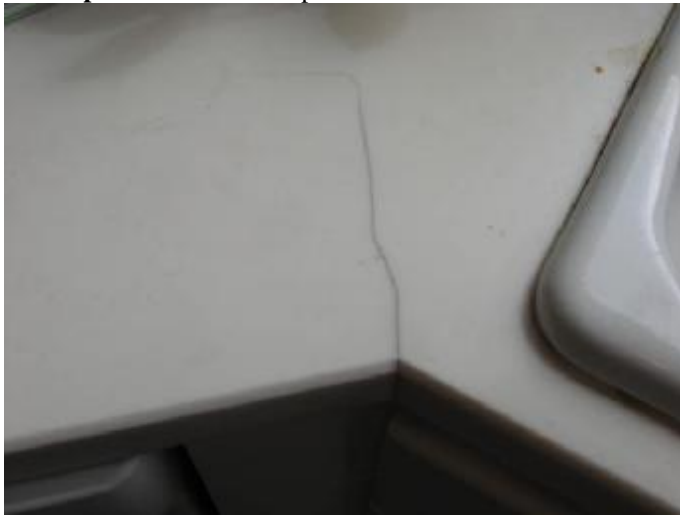
- **Monitor:** The sink faucet is the sprayer type with a flexible connector. Special care should be taken to avoid leaving this sprayer in the sink as wastewater from the sink could be drawn into the faucet and contaminate the water supply.
- **Repair:** The countertop outlets are not GFCI protected. We recommend GFCI protection be provided for all countertop outlets.
- **Repair:** There is an ungrounded 3-hole receptacle on the wall at the right of the sink. We recommend a GFCI protected outlet be installed for safety.
- **Repair:** The refrigerator area is not provided with a grounded 3-hole receptacle and we recommend a grounded 3-hole receptacle be installed.
- **Repair:** The countertop is cracked at the left of the sink and we recommend it be repaired or replaced.

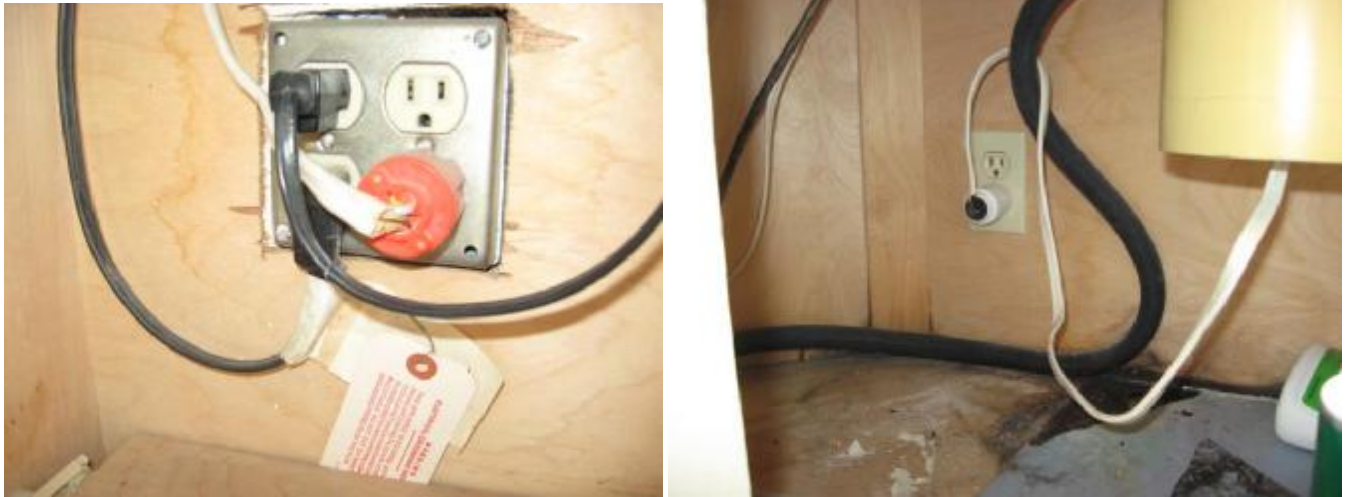
- **Repair:** The disposer and trash compactor are wired with Romex cable with a plug attached. We recommend proper flexible appliance cords be installed. Romex is not proper wiring for appliances, as it requires protection from physical damage. Cord caps are not approved for installation on Romex wiring.

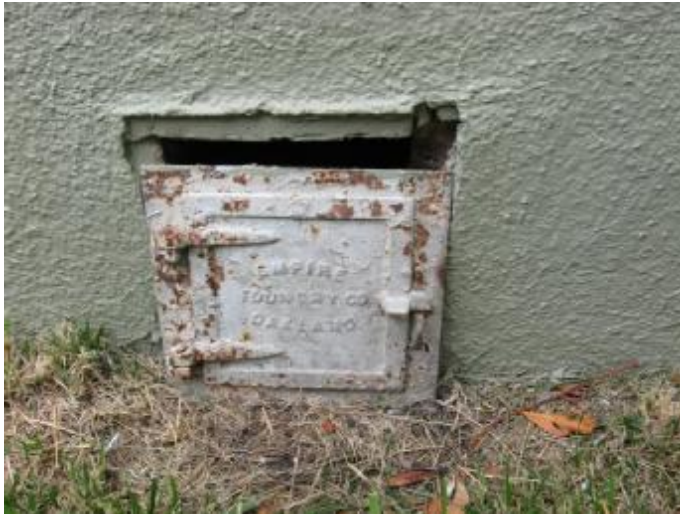
- The chimney has a rain cap and spark screen.
- We applied light pressure to the chimney top above the roof and felt no unusual movement. The top of the chimney was closely examined and we observed no cracking in the chimney above the roof.
- **Repair:** The ash pit cleanout door is loose and we recommend it be repaired to prevent the escape of hot ashes which could be a fire hazard.
